Recurring Seismic Damage in Repeatedly Restored Historic Masonry: A Damage Classification-Based Evaluation of Malatya Teze Mosque*

Lale Karataş Billor¹,
Bursa Technical University, Faculty of Architecture and Design, Department of
Architecture, Bursa, Türkiye¹
lale.karatas@btu.edu.tr
<https://orcid.org/0000-0001-8582-4612>
Received: 14.04.2026, Accepted: 12.06.2026
DOI: **10.17932/IAU.ARCH.2015.017/arch_v012i1005**

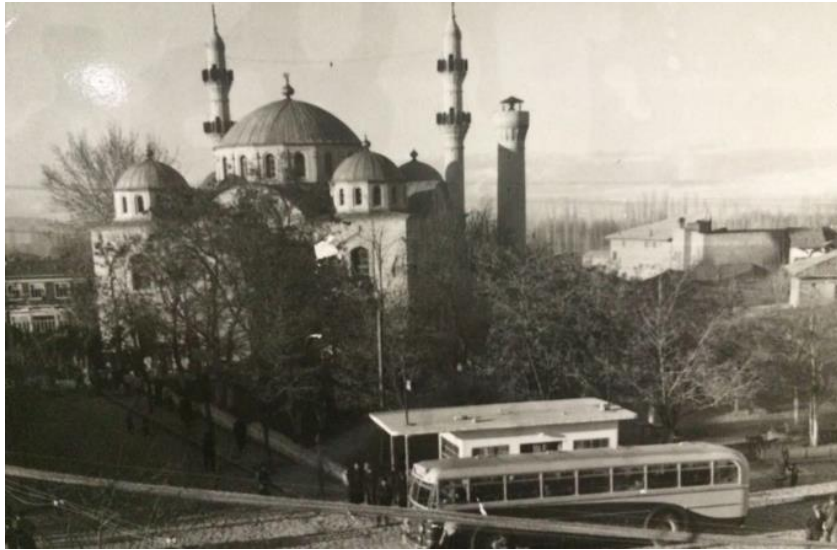
During the 1893 earthquake, the minaret of Malatya Teze Camii suffered a collapse above the balcony level. When the New Mosque (Yeni Cami) was constructed, the minaret was intentionally left unfinished as a memorial to remember the effects of the earthquake. The General Secretary and Historian of Malatya City Council, Abdulkadir Artan, provided some information about the history of the New Mosque and the disasters it experienced, stating the following during a verbal interview: "The minaret with no upper part above the balcony, left by Hocazade Hacı Yusuf Efendi, is a monument of the earthquake. Because you can see the horror of the 1893 earthquake by looking at that minaret" [28] (see Fig. 2).

Figure 2. The original state of the structure and the restoration after the 1893 earthquake, where the minaret was left unfinished as a reminder of the earthquake [28].

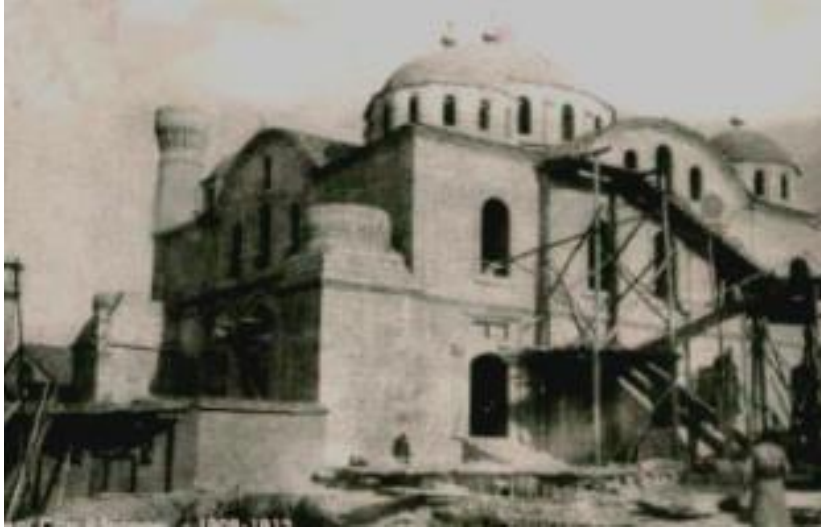
On June 14, 1964, a 6.0 magnitude earthquake struck Malatya on a Sunday at approximately 3:15 PM. During this earthquake, the Malatya Teze Cami experienced several damages, including cracks in the dome and some walls. Some of the stones serving as the base for the minarets' finials, acting as a supporting element for the dome, fell off. Due to the historical context of the event, there is not much detailed archival information available regarding the aftermath of this significant earthquake, which coincided with the decline of the Ottoman Empire.

Figure 3. Damage and restoration of Malatya Teze Mosque after the 1964 earthquake [29]

Following the earthquake, the Vakıflar Genel Müdürlüğü (General Directorate of Foundations) undertook restoration efforts to repair the damaged parts of the cami. The upper parts of the window frames were removed, and the damaged areas were repaired. The lead roofing of the cami was replaced, cracks were filled, and the interior plastering was renewed. In addition, the intermediate dome stones were removed, and larger finials were installed on the minarets, giving them a new shape. The frames of the intermediate

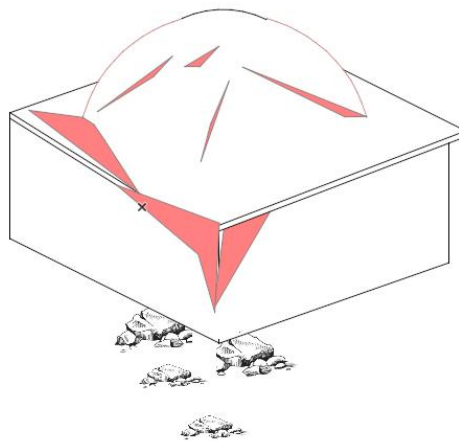
The earthquake that occurred on January 24, 2020, centered in Sivrice with a magnitude of 6.8, caused significant damage to the mosque. The main dome partially collapsed, and walls exhibited shear cracks, while the minaret domes experienced crumbling. Based on the available images from the archives, it is believed that the causes of the observed damages are as follows [30].

Figure 4. Damage caused by the 24th January 2020 Elâzığ- Malatya earthquake - Schematic drawing of the damage (Damage at the corners of the roof or on the main wall, Roof element displacement, Shear cracks on arches) (Developed by the author, 2026)

After the earthquake, strengthening works were carried out on the damaged mosque. During these works, the main dome and other damaged domes were completely removed and replaced. Additionally, buttresses were added to the east and west side walls to reinforce the structure. The interior walls of the mosque were also strengthened, and reinforcement was done on the foundation. In newspaper reports after the 2020 earthquake, it was mentioned that the parts of the mosque that were previously restored were the first to collapse. It was stated by various experts that the added buttresses on the east and west walls collapsed, the newly constructed dome completely collapsed, and the restoration efforts proved ineffective and even worsened the damage [30].

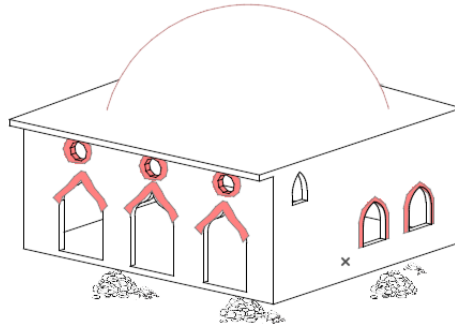
The shear cracks observed in the walls occur when the tensile stress at the center of the walls reaches its tensile capacity. This mode of damage is more brittle and appears as cross X-shaped cracks on the wall, particularly in large stone walls. Figure 5 shows example cases of damage patterns resulting from the tensile stress reaching its capacity at the center of the walls (see Figure 5).

Figure 5. Schematic drawing of the damage (Damage occurring between vertical walls due to different material usage, insufficient connections, previous inadequate reinforcement interventions, or lack of maintenance, Crumbling or loss on corbels) (Developed by the author, 2026)

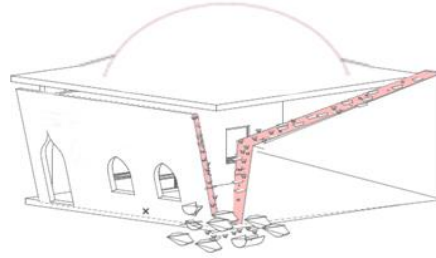
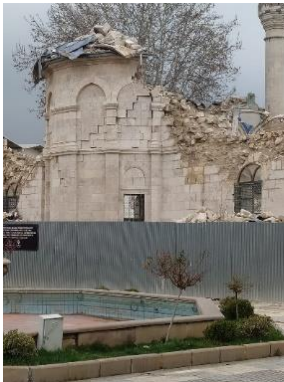
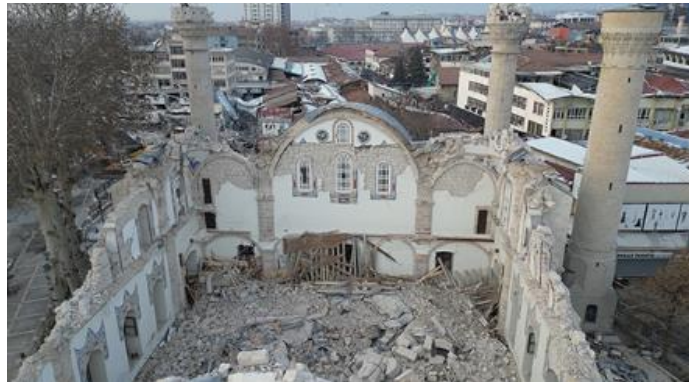
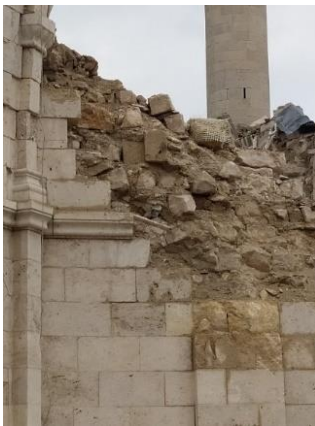
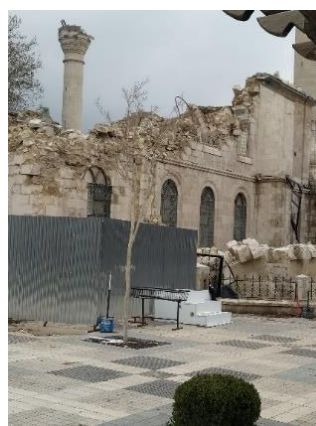
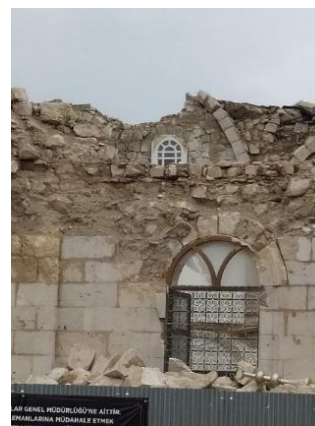
The structure has double-walled construction, with the outer and inner wall layers made of different materials. The outer wall layer consists of perfectly cut stones, chosen for their richness and solidity, while the rest of the structure was constructed with rubble stones. This resulted in different rigidity for the two layers during the earthquake. The earthquake forces exerted more impact on the outer wall layer, while the inner wall layer, being more flexible, was less affected. The irregular and non-monolithic nature of the stone walls, coupled with negligible tensile strength and high mass, led to the early occurrence of local failure mechanisms during seismic events.

These local mechanisms were not mitigated through proper construction details and structural connections, leading to partial collapse. The connections between the outer and inner wall layers in the double-walled construction also played a significant role in the partial collapse of the walls. The walls were built using weak binding materials like lime mortar and earth mortar. Earth mortar was mainly used in the inner part

of the wall layer and its low binding properties, low compressive strength, and sensitivity to moisture resulted in further weakening of the wall element's rigidity. Additionally, the adverse effects of atmospheric conditions (such as temperature and rainfall) caused deformations in the mortar and joints over time, leading to cracks in the structure during earthquakes. The low-strength properties of the mortar, the use of earth as filling material, and inadequate wall connections contributed to the weakening of the walls and facilitated separations during the earthquake (see Figure 6).

Figure 6. a) Schematic drawing of the damage (Developed by the author, 2026) (b) Images illustrating the vulnerability created by the joining of different types of materials, such as cut stone and rubble stone, used in double-walled construction, in the presence of earth mortar (The images used in this study were obtained from the following source: AA Haber[30] , Malatyahaber. (2023)[31] and Busabah Malatya (2023) [33].

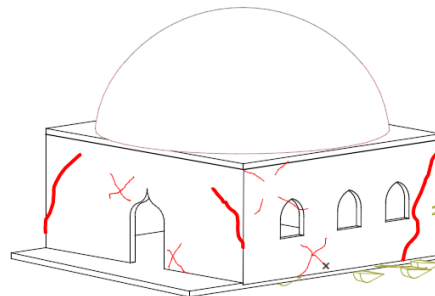
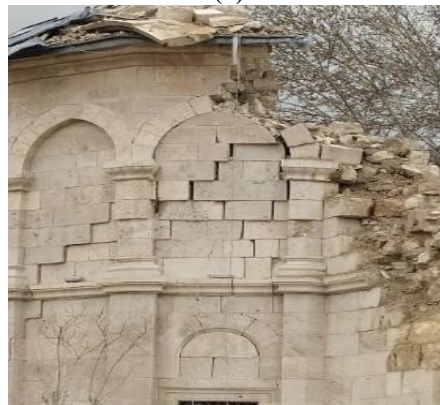
Another finding is the weak mortar connection in the structure. Mortar material is a crucial component that holds the stone blocks together. It fills the gaps between the stone blocks, providing structural integrity, flexibility, and resilience to the building. During an earthquake, the distribution of horizontal and vertical forces in the structure is significantly influenced by the quality of the mortar. The load-bearing characteristics of the walls depend on factors such as the type of stones used, the quality of the mortar, and the connection details, all of which affect the behavior of the walls during an earthquake.

The emptying of mortar in the masonry of stone structures has several negative effects during earthquakes. It weakens the connections between stone blocks, rendering the structure less resistant to seismic forces, making it more susceptible to collapse or damage. In cases where the mortar is missing or weak, the displacement and sliding of stone blocks during an earthquake are more likely, resulting in structural deformation and cracks in the building. Insufficient strength of connection elements also makes the structure more vulnerable. If the connections are too weak or missing altogether, partial wall displacements and collapses can occur during an earthquake, subjecting the walls to significant loads.

During field inspections, it was observed that natural factors over the years have led to the weakening and erosion of the mortar in the structure. The problem of wall displacement due to weak mortar connections was prevalent in the examined building. The emptying of mortar has compromised the structural integrity of the stone masonry, reducing its resistance to shaking motions, resulting in more extensive damage to the building (see Figure 7) [34].

Figure 7. a) Schematic drawing of the damage (Developed by the author, 2026) b) Shear cracks in the main body of the wall due to the weakness of the mortar (The images used in this study were obtained from the following source: AA Haber (n.d.))[31]

- (III) Long-term environmental effects have significantly weakened and eroded the mortar in the masonry over time. Before any restoration, a detailed characterization of the existing mortar is necessary to understand its mechanical properties and compatibility with new materials. This step is crucial for achieving durable and seismically compatible repairs.

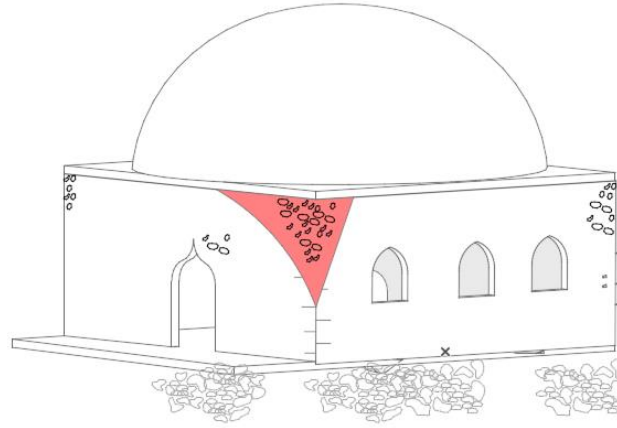
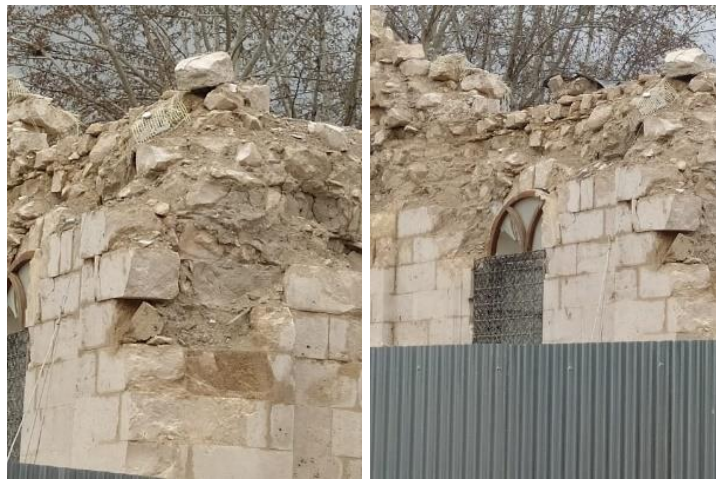
The lack of horizontal bonding stones in the wall joints of the structure resulted in the detachment of walls and separation of stone surfaces. Adequate bonding capacity is essential in rubble masonry structures, typically achieved through corner stones. Various studies [35-37] emphasize that horizontal bonding stones in stone constructions provide horizontal sliding planes, distribute energy, and enhance the durability of stone walls, thus improving earthquake performance of the buildings. This technique reinforces the horizontal connections between walls, helping to bind the leaves of a wall together and prevent disintegration. The section below illustrates damages caused by the absence of corner connections in the structure (see Figure 8).

Figure 8. a) Schematic drawing of the damage (Developed by the author, 2026) b) Typical multi-story wall sections with missing horizontal bonded stones and inadequate corner stone connections (The images used in this study were obtained from the following source: AA Haber (n.d.) [31])

- (II) The stone walls of the Teze Mosque are highly susceptible to damage mechanisms such as partial collapse, settlement, and out-of-plane overturning during earthquakes. These damages are primarily caused by insufficient connections between structural elements, the double-leaf wall system with differing rigidities, and the use of weak bonding mortars (lime and earth mortar). The absence of adequate cornerstones and through-stones further contributes to wall separation and disintegration. To mitigate these issues, proper structural connections, compatible materials, and enhanced wall interlocking details should be employed in future interventions.

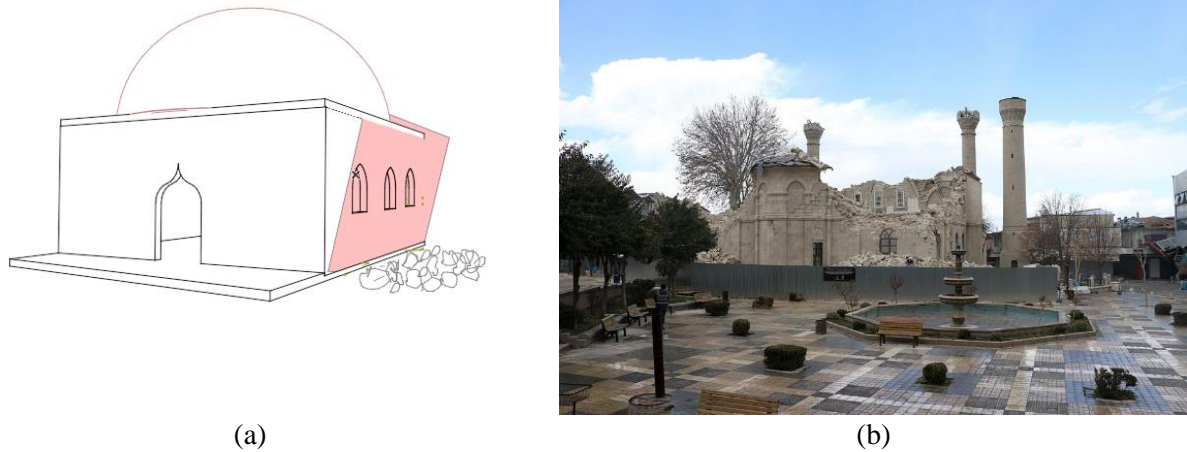
The toppling of walls in the corners of the structure is also prevalent in the building. When buildings lack "box-like behavior," meaning that structural elements are not interconnected with unified lateral diagrams, bending occurs in the inertia forces of walls perpendicular to the earthquake effect. Under such effects, the capacity of stone walls significantly decreases, leading to the collapse of many walls in events similar to

the Turkey earthquake. Long walls or walls without adequate lateral support undergo vertical, one-way bending. Particularly in the structure, two-way bending is observed, especially in the upper parts of facades with inadequate connection to the roof (see Figure 9).

Figure 9. a) Schematic drawing of the damage (Developed by the author, 2026) b) Toppling of the entire wall or a portion of it out of the plane (The images used in this study were obtained from the following source: Habername. (2023, March 7)[32]

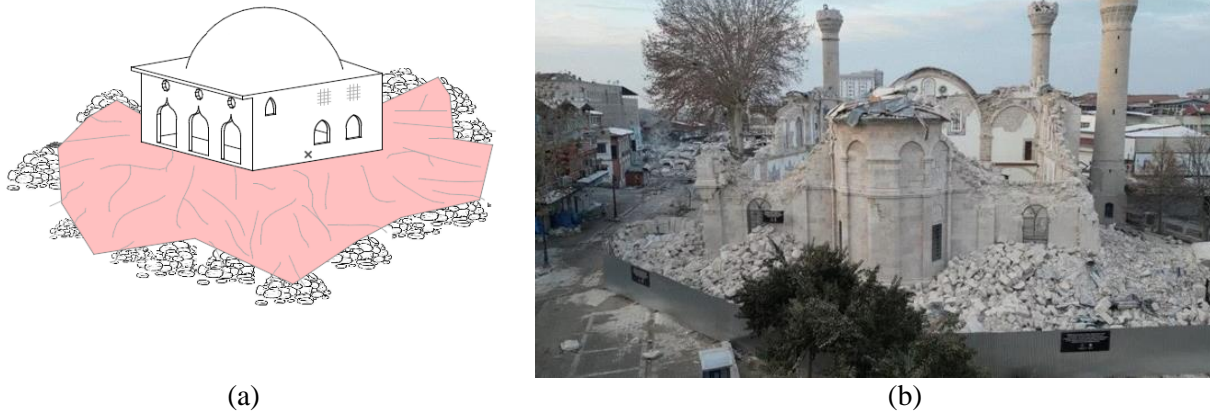
The foundation on which the stone walls of the structure rely is an important component that provides support to the building. The foundations and ground conditions of stone structures are significant factors that affect the durability of the buildings. An inadequate or low-quality foundation can lead to the collapse and settlement of the upper parts of the walls during earthquakes [4]. Based on archival research regarding the site where the mosque is located, it is reported that the area was known to have weak ground conditions when the mosque was constructed. The 1894 Mamuret-ül-Aziz Salname [38] provides the following information about the foundation: "During the excavation of the mosque's foundation, a substantial amount of water emerged, and juniper trees were used to prevent waterlogging. After the workers drove the piles into the ground, they filled the hole created with a paste-like substance known as 'log'. This suggests that the characteristics of the ground and foundation of the structure may have influenced the potential wall collapses during the earthquake. Further investigation is needed to understand the site conditions, groundwater level, and adequacy of the building's foundation (see Figure 10).

Figure 10. a) Schematic drawing of the damage (Developed by the author, 2026) b) Damage images attributed to ground-related issues (The images used in this study were obtained from the following source: Busabah Malatya (2023) [33])

- (I) Malatya is located in the impact zone of the East Anatolian Fault (EAF), one of the most active faults in the world. Therefore, improving foundation stability and considering local soil conditions are essential before any restoration work. A detailed geotechnical investigation should be conducted prior to restoration, and appropriate ground improvement techniques — such as epoxy grouting or soil consolidation — should be implemented to enhance the foundation’s performance.
