Materials Used in the Construction of Village House in Van

Hakan Irven, Bilge Işık
Institute of Science Master of Architecture
Istanbul Aydın University, Florya Istanbul /Turkey
E-mail: hakanirven@gmail.com

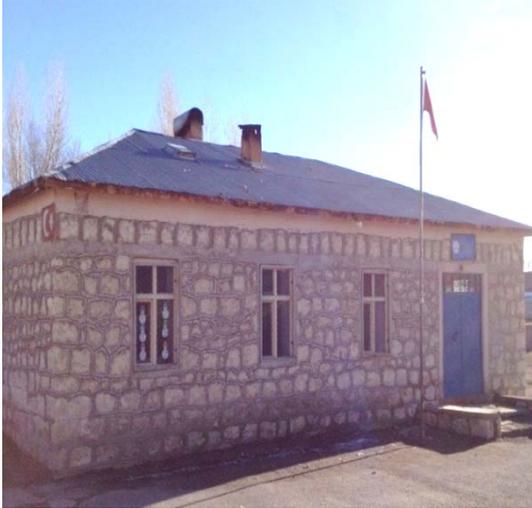
Figure 1. Village of Bayramli / Van/ stone school building [Irven, H.] photographed by Hakan Irven
Figure 2. Village of Hamurkesen/ Van / Adobe building

The natural stone which was formed for thousands of years in the nature has a high strength. So, the features of the material can remain the same [3]. The buildings made in the previous periods were constructed on the basis of the material's strength under the pressure. In the structure building process masonry structures were made by placing the stone on each other with a particular system. Both the existing conditions and the easy providing were effective in the choice. Nowadays the new technological conditions, the desire of high structured buildings together with the decrease of stone craftsmen reduced the commitment to this material. Today, stones are preferred mostly for decorative purposes.

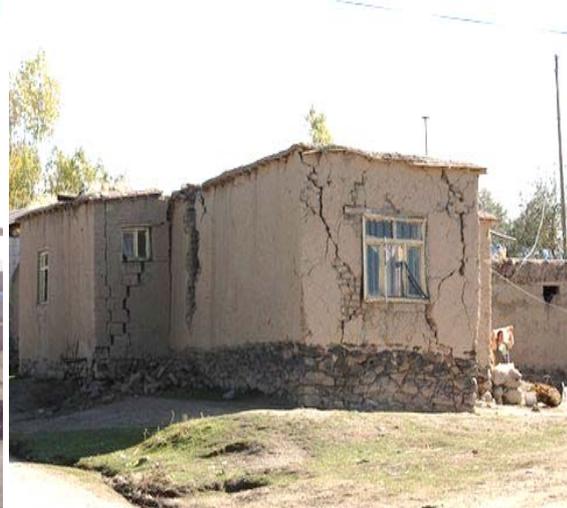
Adobe; is a building material made by pouring the mixture of soil, straw and hay into moulds in the size and form of a brick (Figure 2). Adobe is a material used in every regions of our country. It is used less in the rural areas of Eastern Anatolia. Nowadays, with the increase of industrial building materials it can be said that the usage ratio of the adobe is reduced. Adobe which is a traditional material uses less energy at the stage of production and consumption. It came up again recently because it is an environmental friendly building material. Adobe which is a type of mud with a suitable consistency which was prepared by being mixed with straw in a pool and then it got the desired size by filling it into wood molds. In the structure, from the ground up to the window level, adobe which is sensitive to water gives its place to stone material. The adobe material is also known for creating an air conditioning effect in the building.

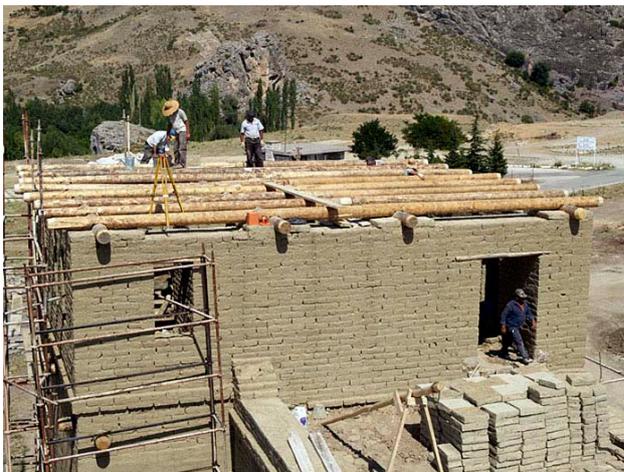
Wood used often as a material in every period, continues today to be a material by increasing its importance. In the past, in the structure of the village houses wooden beams were preferred due to passing the opening in the upper floor, making light roof (Figure 3) and easy manufacturing. Today, wood is used generally for decorative purposes.

Figure 3. Village of Karahan / Van / Application of wooden roof [4]
Figure 4. Village of Bayramli /Van / stone foundation photographed by Hakan Irven

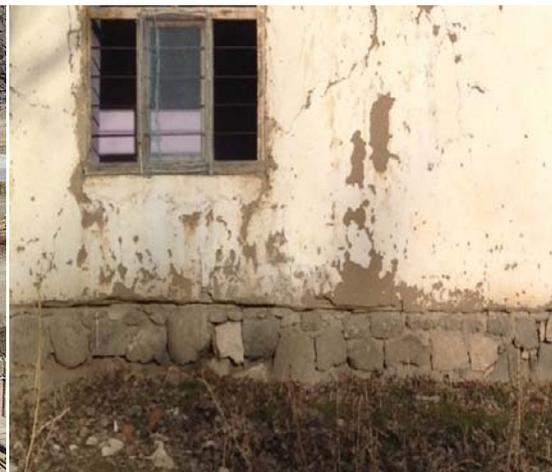
The richness of the region in stones and rocks was the main reason for the use of natural stones. Stones are placed until a certain socle elevation. Soil is put on the top of the stones as heating isolation. The surfaces are often plastered with mud (Figure 4).

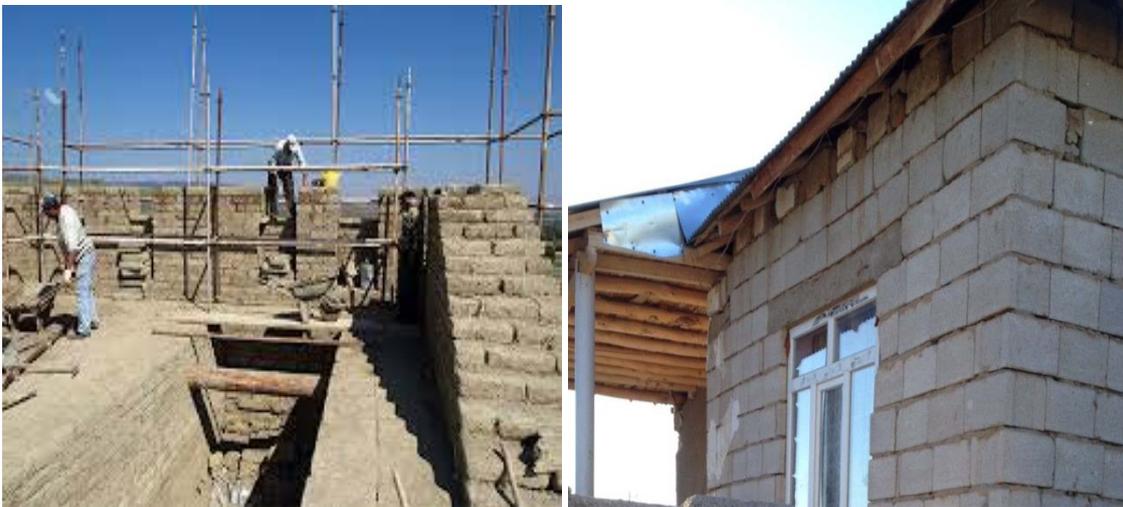
The poplar trees which are preferred in the region due to their cultivation and rapid growth were used as roof beams on many of the upper floors, then nylon canvas was laid down on the top of the roof beams (Figure 5). Then soil was put on the top of the nylon and so the flat roof was constructed. Sometimes cane found in the region was used as a cover at the top (Figure 6).

Figure 5. The construction of adobe wall

Figure 6. Village of Bayramli /Van/ upper wooden columns photographed by Hakan Irven

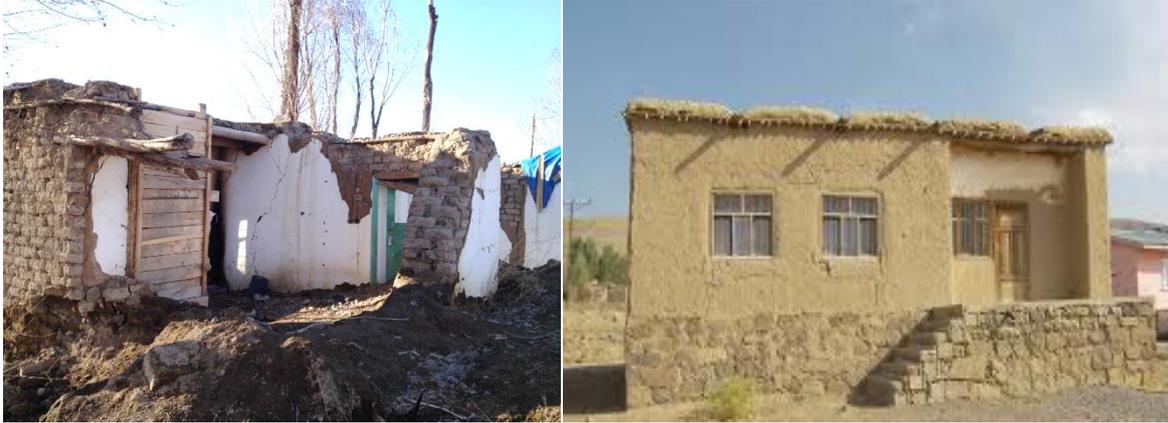
Basic: The foundation structures with the use of stone is very important for the strength between the ground and the building (Figure 7, 8)

External surface: was made by using stone and adobe. The surfaces were plastered with mud material (Figure 7, 8)

Upper floor: wooden beams (poplar tree) and cane are frequently used (Figure 7, 8)

In Figure 7, we can see examples from the village of Bayramli for buildings made from adobe before 1990. It was used until the earthquake occurred in 2011, after the earthquake it was abandoned. The building in Figure 8 is an example for adobe structure in the rural area of Van before 1990.

Figure 7. Village of Bayramli / Van/ structure from before 1990 photographed by Hakan Irven

Figure 8. Village of Ocakli / Van / structure from before 1990

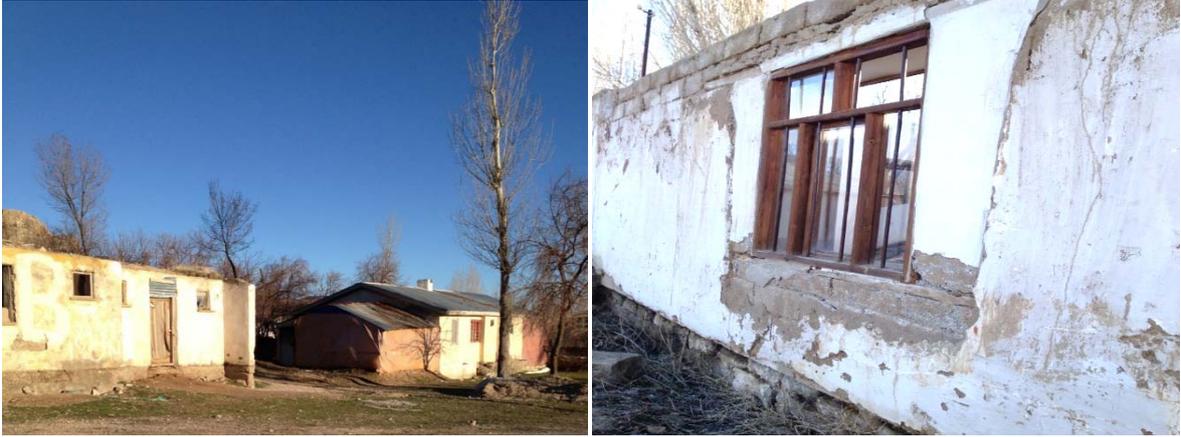
Together with the rapid transformation of the city the broken connection of the villages with the city began to close. The individuals living in the villages observing the development of the city have entered into various seeks. At the same time together with the multiplication of the individuals who were educated of the transportation, infrastructure and workforce development, a noticeable transformation-change was observed in the houses of the village. During this period, in addition to the structure made before 1990 as a result of the fact that the materials arrived to the region and the economic opportunity reached the level of purchase, they started to use briquette and concrete plaster for the external walls, glass wool for the heat isolation of the upper floor, and sheet metal cover for the upper cover. In the course of time, together with the transformation of the material change, different solutions started in the spatial planning. Worry can be seen about the different colours of the external walls on the building's surfaces. In this context, in some of the buildings identity changes can be observed that occurred in the buildings of the village. Without the uniform planning of the building surfaces, besides the effort to create a number of moving surfaces, worries about the different colour of the exterior paint are seen on the surfaces (Figure 9, 10)

Figure 9. Village of Bayramli / Van photographed by Hakan Irven

Figure 10. Village of Bayramli / Van / Briquettes of the external wall photographed by Hakan Irven

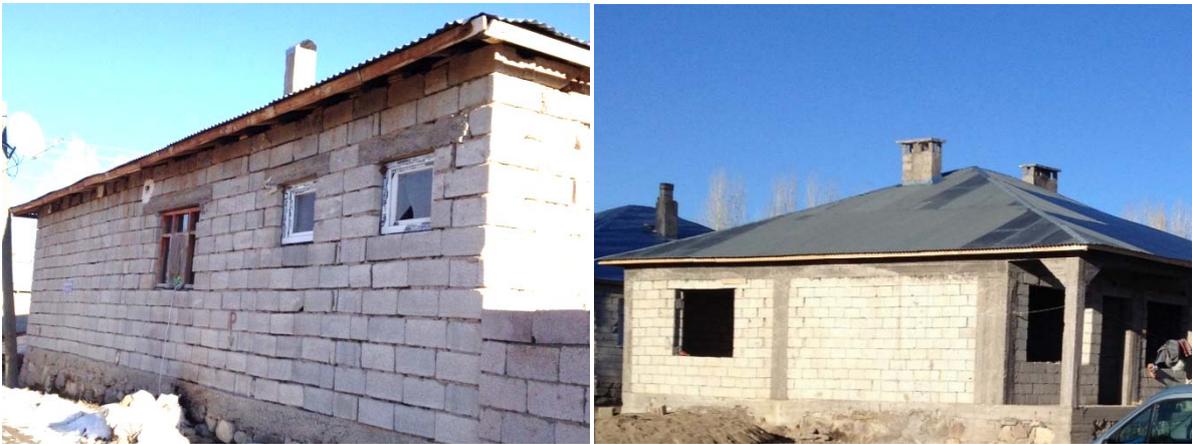
After 1990 in the building of Figure 11, 12 as it is seen, briquettes were used instead of adobe, the surfaces were plastered with concrete and were painted with whitewash. The window is divided into several panes instead of using one eye window. This also shows that various aesthetic seeks entered in the buildings. It is often observed that they used sheet metal cover for the upper floor coverings. In the area where heavy snowfall occurs together with the easier commute of the materials to the village, this transformation has become an active cause in the choice.

Figure 11. Village of Bayramli / Van/ Application of briquette structure photographed by Hakan Irven

Figure 12. Village of Bayramli / Van / Application of masonry structure photographed by Hakan Irven

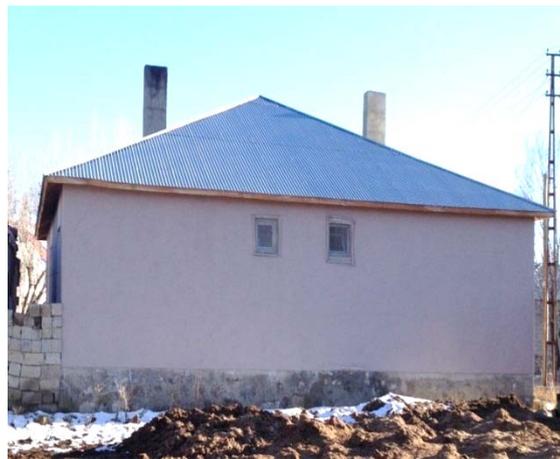
Figure 13. Village of Bayramli / Van/ building in the last period photographed by Hakan Irven

The activities of change-transformation occurred in the village houses after the 1990s have gained speed. In the following years, the heat isolation and planning principles in the buildings have been adopted by the individuals. In this context, change and transformation can be observed within the framework of the emerging opportunities during this course of time in the rural area of the city of Van. This transformation in the countryside was not made by a plan and program; this should be done completely according to the basis of the individuals' own formats and planning (Figure 13).
